Shelter, Retrofit, and Reconstruction of Housing

*A Summary of Previously Used Strategies in Developing Regions
Applicable for the 2015 Lamjung, Nepal Earthquake*

A Report Prepared for the World Bank by

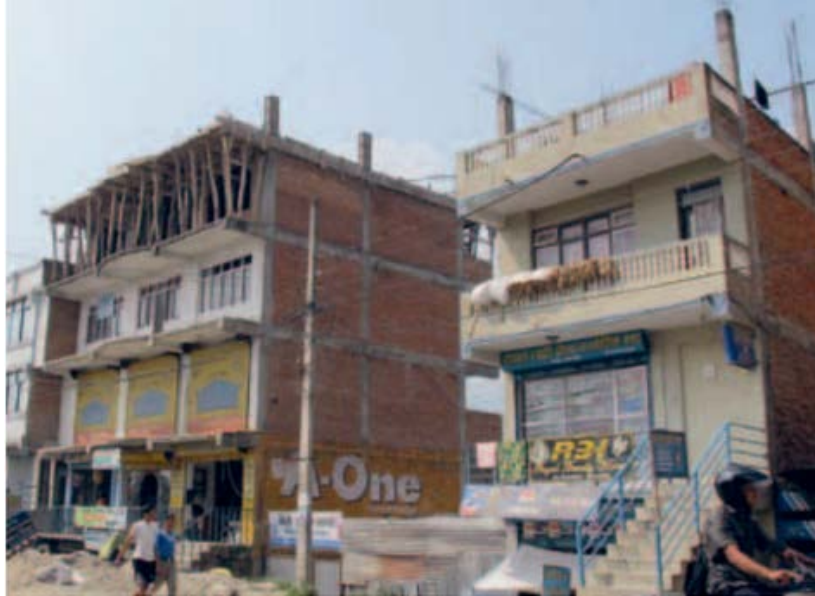
Figure 3.2. Incremental construction of an RC framed building with masonry infill walls³

Densification of urban areas has led to the construction of taller buildings through incremental construction (see Figure 3.2), and houses that are four to five stories are no longer uncommon. Additionally, apartment complexes of a dozen stories or more have appeared on the Kathmandu skyline. Building codes exist, but are rarely enforced due to economical considerations.

Modern houses are usually reinforced concrete framed structures with brick masonry infill walls (Figure 3.2), and are known locally as “pillar-wala ghar”, which literally translates to “house with columns”. Gravity and lateral loads are resisted by both the RC frames and the masonry walls. The RC frame may or may not be connected to the masonry walls by means of horizontal or vertical reinforcement. These RC frames are usually non-engineered structures, and commonly have seismically-deficient non-ductile detailing. Nonetheless, this is currently the most prevalent form of urban construction. Nepal has not suffered a major earthquake since the introduction of this form of construction, so there is a general misconception among the public that this is the safest type of house than can be constructed. This is the preferred form of construction for any family that can afford it².

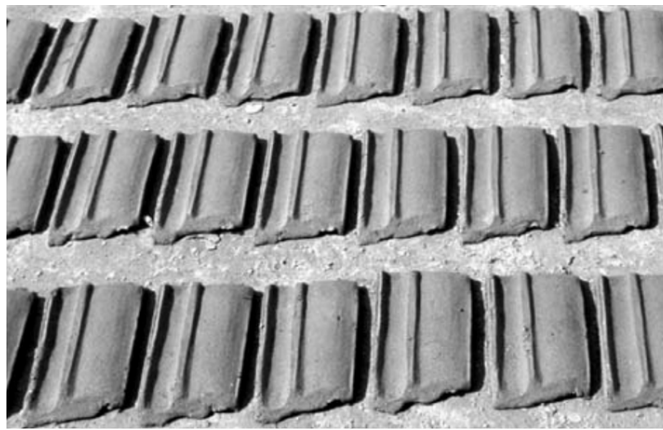
Figure 3.3. Clay roof tiles¹

Roof tiles are made from the same clay as masonry bricks. They are flat and have two longitudinal grooves where one tile can be fitted to the next, as shown in Figure 3.3.

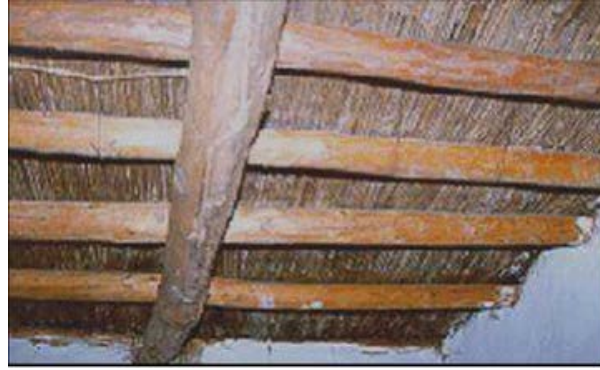
Figure 3.4. Timber floor⁵

Kathmandu means “city of wood,” and timber is one of the oldest and most extensively used building materials in Nepal. It is used in house construction for doors, windows, staircases, flooring, roofing, and wall panels, as well as for structural members such as columns, beams, and trusses. Timber flooring, bands, and corner knee-braces are sometimes used in home construction. A typical timber flooring system is shown in Figure 3.4.

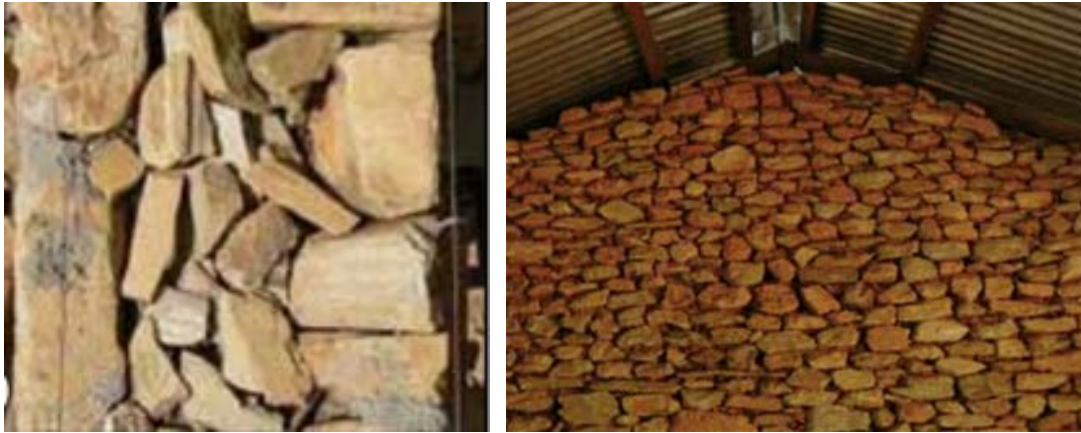
Figure 3.5. a) Cross section of a double-wythe wall and b) gable wall made of stone⁴

Houses may be made completely out of stone, or stone may be used for portions of the house. The brick walls of Newar houses, for example, stand on stone foundations. Stone masonry walls are supported by continuous stone masonry strip footings. In some rural adobe houses, the first floor walls are also made of stone. In urban areas, entranceways around doors may be made of stone. Stone may be stacked without the use of mortar, or mud or cement mortar may be used. Like bricks, stone may be used to construct double-wythe walls. Examples of stone walls are shown in Figure 3.5.

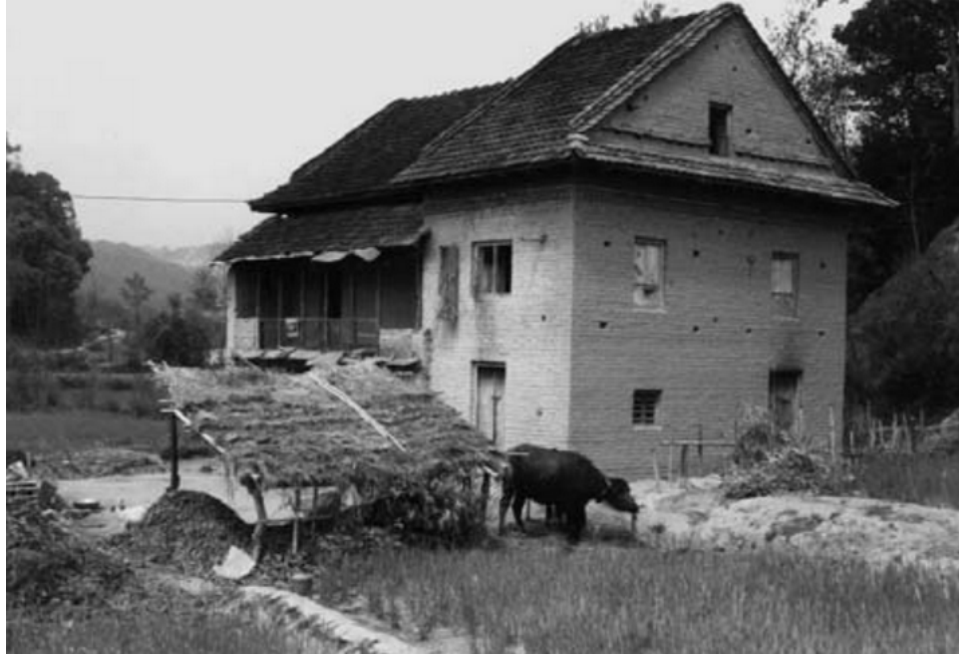
Figure 3.6. An adobe house¹

Adobe refers to sun dried bricks made from clay earth. Adobe is common in the agrarian and rural areas surrounding the Kathmandu Valley, particularly along the Bagmati River³. An example of an adobe house is shown in Figure 3.6. Bricks are usually made with earth found near the building site to minimize transportation costs. They are molded and left to dry outside. The same earth is used for making the mortar. Using adobe lessens energy and environmental impacts when compared to traditional bricks. Additionally, little skill is required to make adobe. Adobe blocks can be compacted by using a machine to increase compression strength; it is unknown how widespread the practice of compacting blocks is.

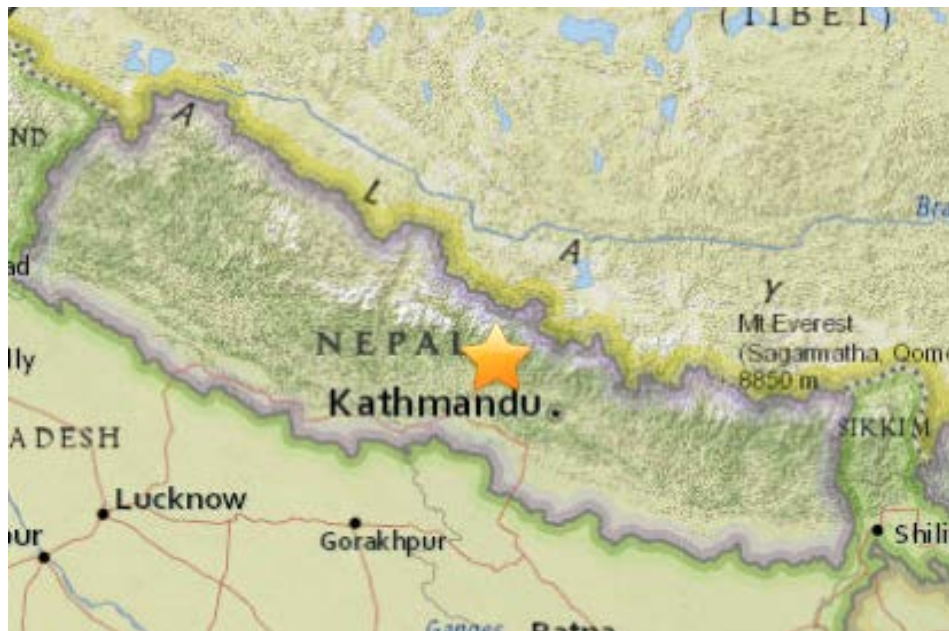
Figure 4.1. Location of the epicenter of the April 25, 2015 Nepal Earthquake

On April 25, 2015 at 6:11:26 local time (UTC), a magnitude 7.8 earthquake struck Nepal eighty kilometers northwest of the capital, Kathmandu, as shown in Figure 4.1. Seismic energy was directed eastward with approximate fault area dimensions of 120x80 kilometers⁶. The hypocenter is estimated to be at 28.15N 84.71E, at a depth of 15 km⁷.

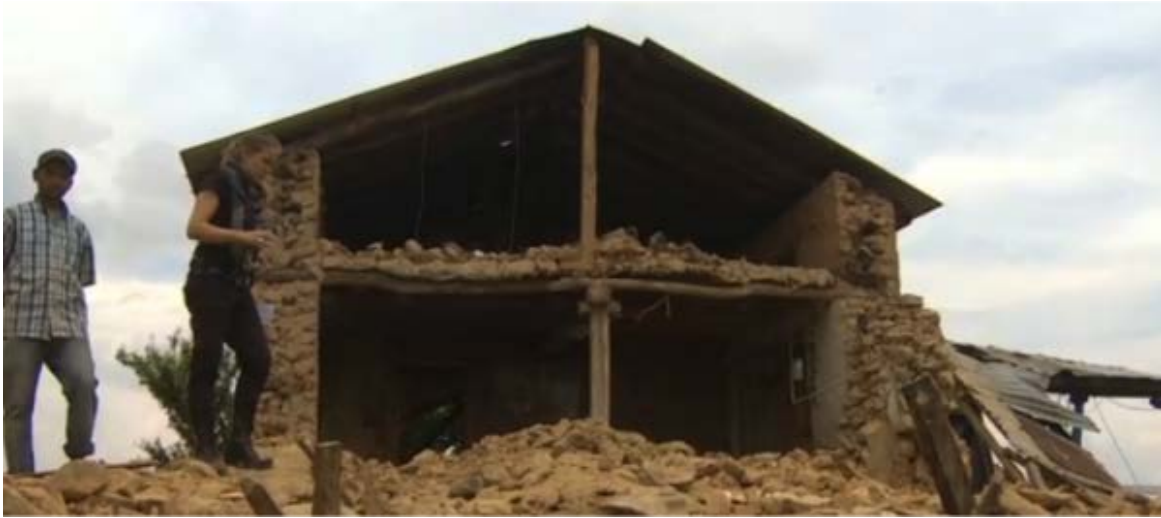
Many of the structural, construction, architectural, and material deficiencies are seen through representative photos from topical articles and social media posts. In many cases, stone walls have collapsed in their out-of-plane direction. This was seen in Ravi Opi (Figure 5.1) with several foot thick walls. It does not appear that anything tied the stone walls to each other. The roof was made

of sloped timber with metal sheathing, however, no diaphragm existed connecting walls at the top of the second story of the structure.

Figure 5.1. Location: Ravi Opi, Nepal (Source: CNN)

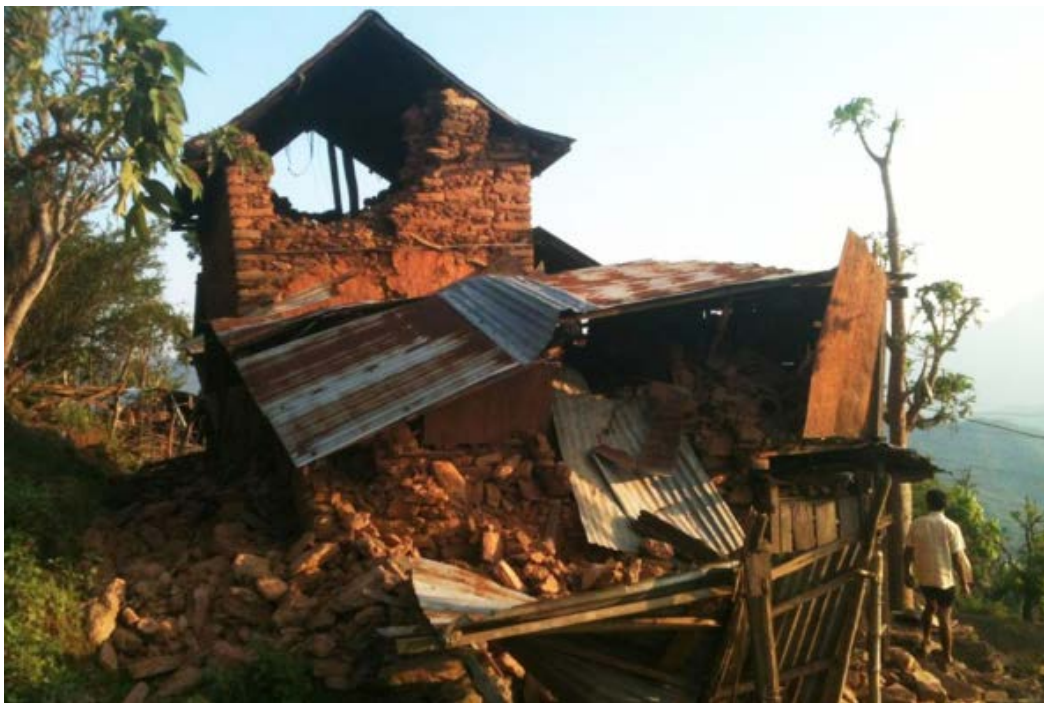
A similar situation was observed in the Paslang village, pictured in Figure 5.2. A thick stone/brick wall with limited mud mortar collapsed out-of-plane, with a galvanized iron roof sheathing supported by a timber gable roof still standing.

Figure 5.2. Location: Paslang village, Nepal (Source: CTV)

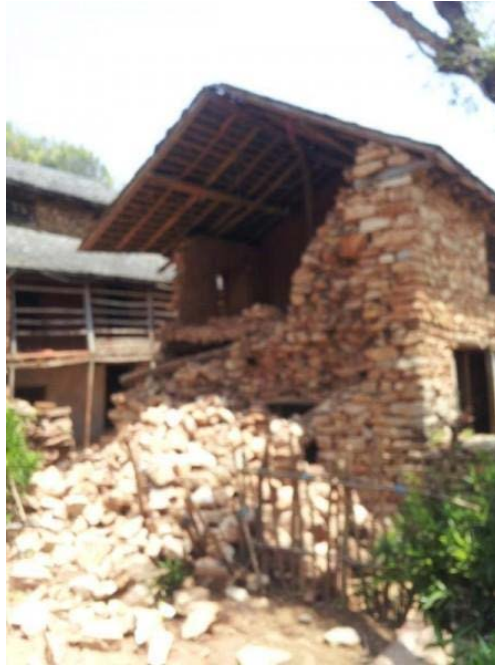
Another rural Nepal example in Figure 5.3 shows that the timber roof with galvanized iron sheathing may not be adequately connected to all walls. In this case, a stone wall has collapsed while the roof remains, cantilevered from walls that have not collapsed.

Figure 5.3. Rural Nepal. (Source: Tom Newby)

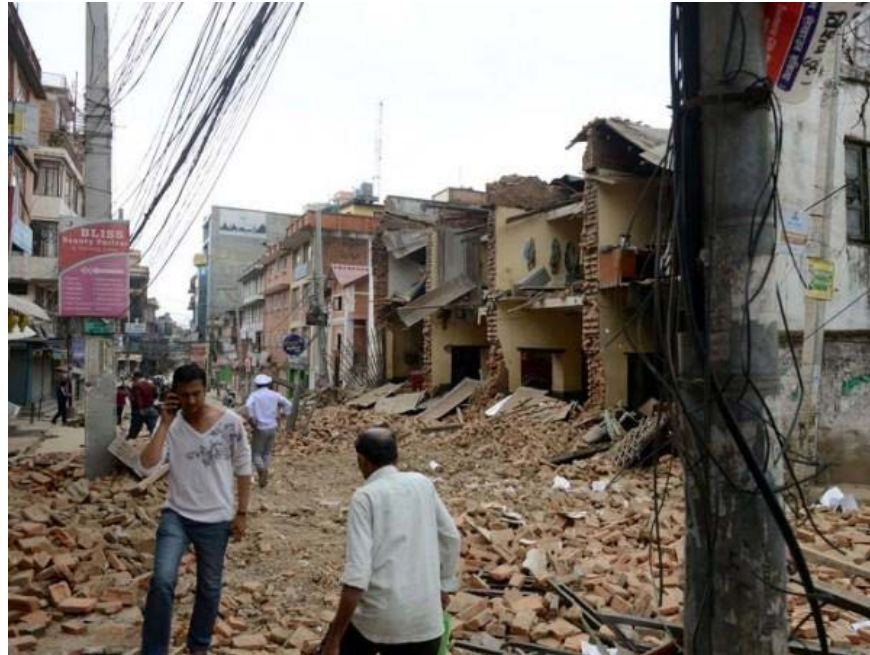
Urban areas with brick and mud mortar construction experienced similar out-of-plane wall collapses, without full structure collapse. Lalitpur is pictured in Figure 5.4. Multiple brick facades have collapsed outwards. The many loose bricks in the street indicate a lack of mortar, or effective mortar in construction.

Figure 5.4. Location: Lalitpur, Nepal (Source:NPR)

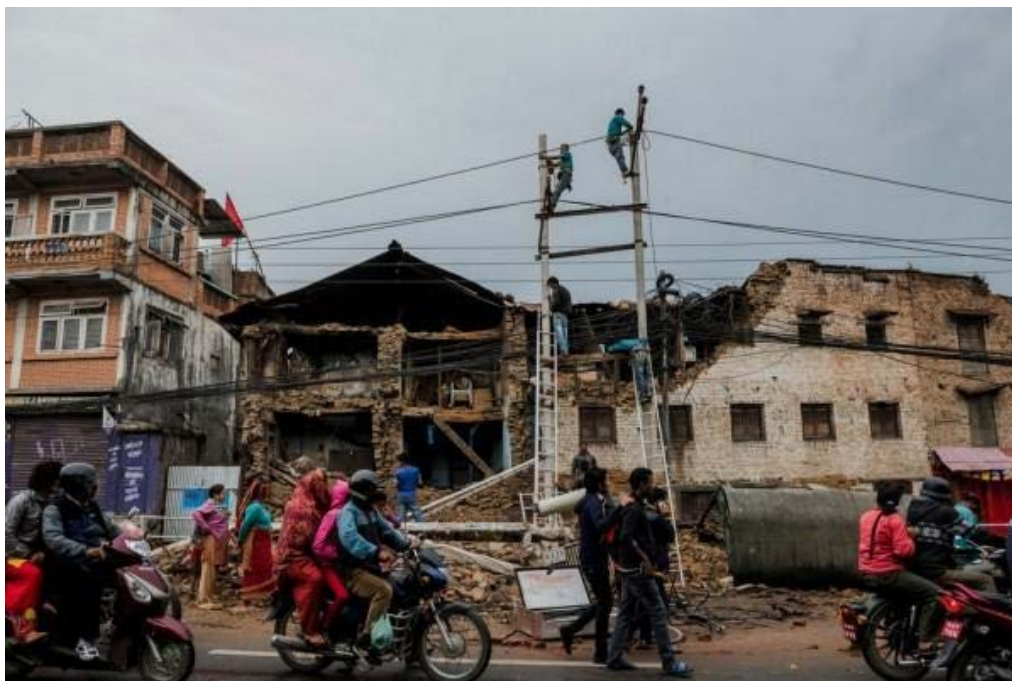
A similar failure is seen from Kathmandu in Figure 5.5.

Figure 5.5. Location: Kathmandu, Nepal (Source: New York Times)

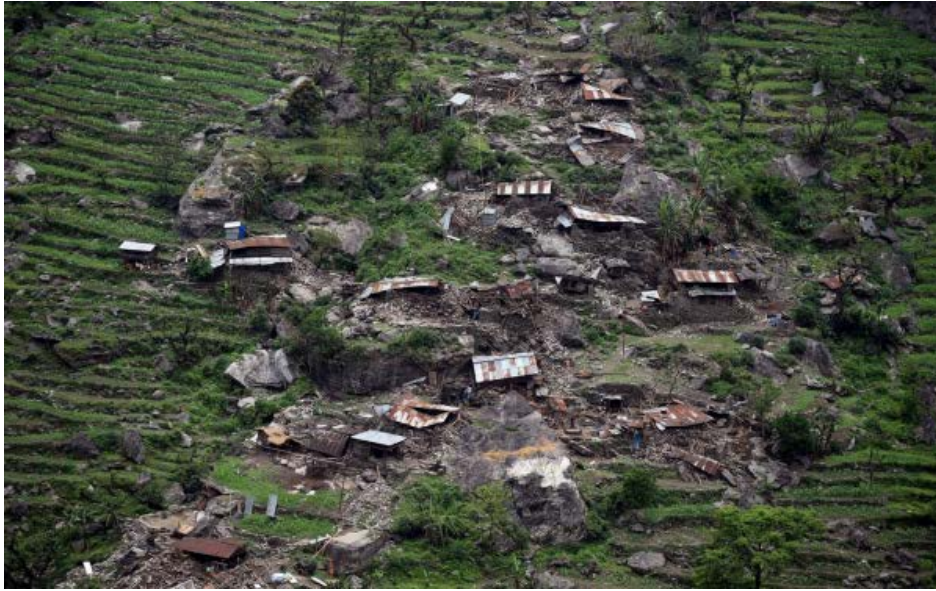
walls, and mortar is often not used either, so the only lateral resistance is provided by friction between the pieces of stone.

Figure 5.6. Location: Gorkha, Nepal (Source: New York Times)

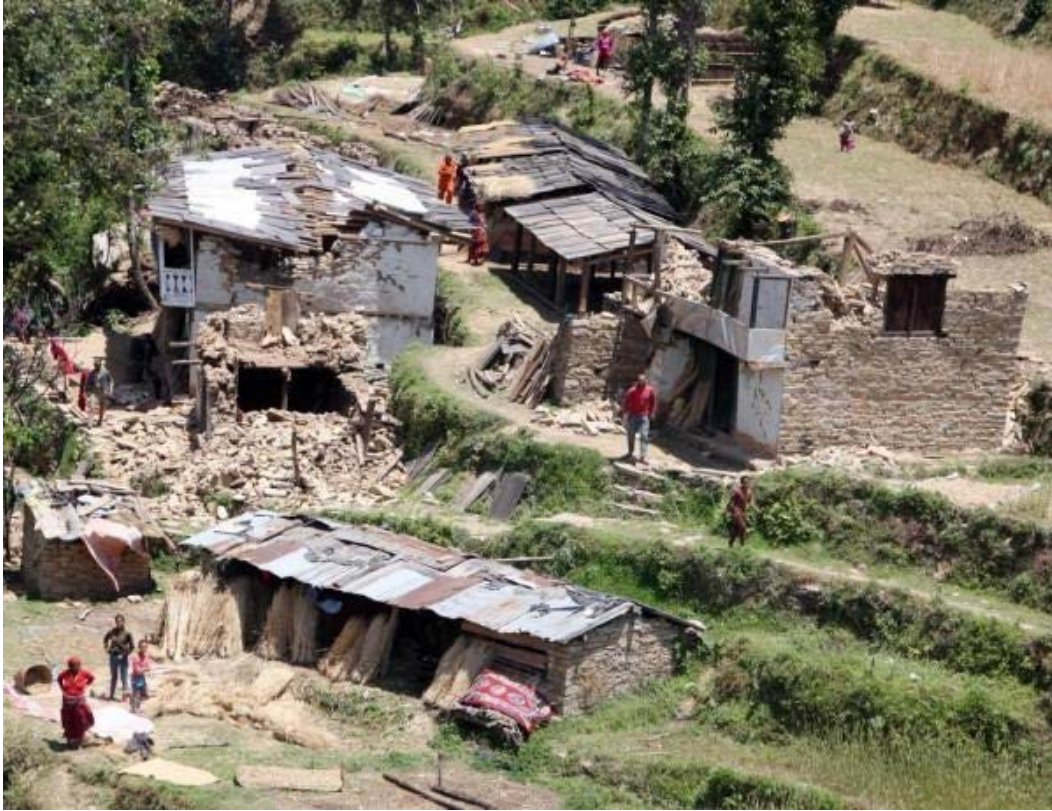
In some cases, such as in Chautara, damage is binary. Taller stone structures are seen to have collapsed while a one-story stone structure with a light galvanized iron sheet roof has not. Another light structure with wood posts and a galvanized iron sheet roof does not appear to have sustained damage.

Figure 5.7. Chautara. (Source: Sitanshu Kar)

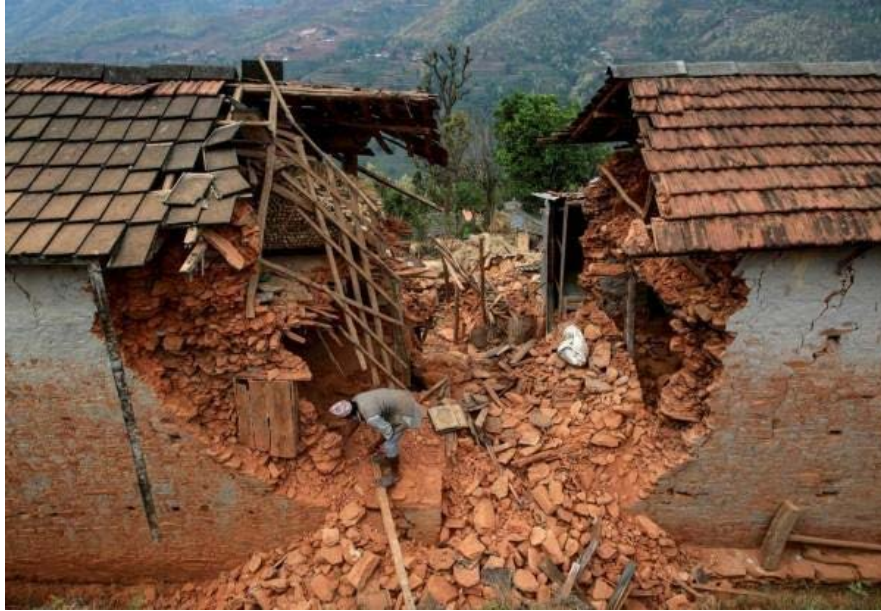
Figure 5.8. Location: Sindhupalchok, Nepal (Source: Reuters)

Material weaknesses were a significant problem during the earthquake. A photo of a house in Sindhupalchok (Figure 5.8) shows that many of the bricks crumbled. This is likely due to a lack of cementitious material in making the bricks. They are often made through compression only in Nepal¹⁹.

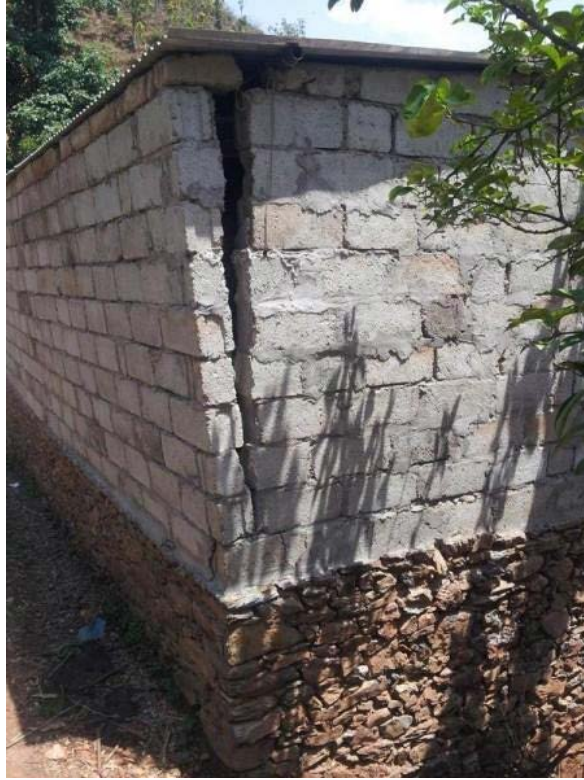
A structure in rural Nepal that uses concrete masonry unit (CMU) blocks with cementitious paste between the blocks has survived the shaking. Shown in Figure 5.10, the walls have acted as one unit, rather than independent blocks, which likely prevented the structure from collapsing. Still, nothing is seen to have tied the perpendicular walls to each other.

Figure 5.10. Rural Nepal. (Source: Tom Newby)

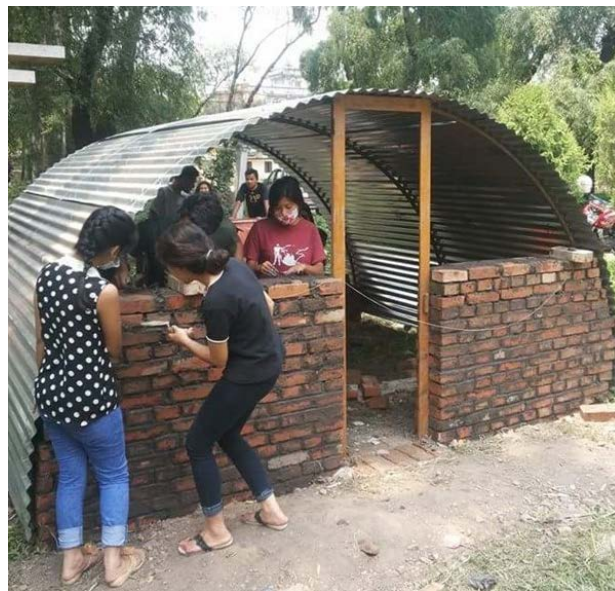
Figure 6.2. Community members assisting with reconstruction

Material availability is a large concern for building shelters in Nepal. Galvanized iron sheets may be readily available in both urban and rural locations because it has commonly been used in the past for residential construction. Similarly, stone or brick can be salvaged from collapsed structures. An important additional aspect of reconstruction is involvement of the community. In Figure 6.2, community members can be seen assisting in the construction efforts.

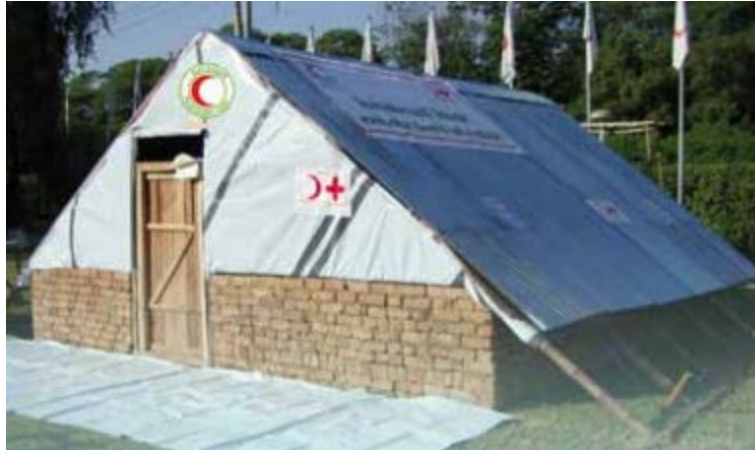
Figure 6.4. Shelter following 2010 flooding in Pakistan

Following flooding in 2010 in Pakistan, 10,000 galvanized iron sheet based shelters were constructed²¹. A timber frame built on low brick or stone walls supports galvanized iron sheet gable roofing, as pictured in Figure 6.4. A plan and cross-section are shown in Figure 6.5.

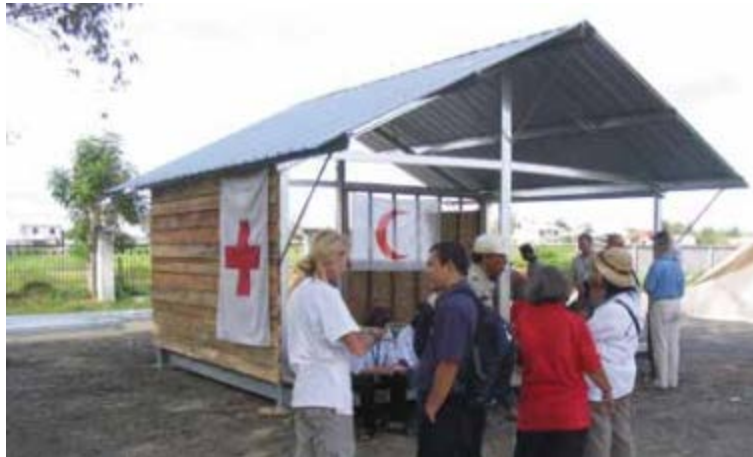
Figure 6.6. Timber frame with CGI sheet roofing from Indonesia

Timber planks were used for sheathing and flooring. The shelter is shown in Figure 6.6 with a plan and cross-section shown in Figure 6.7.

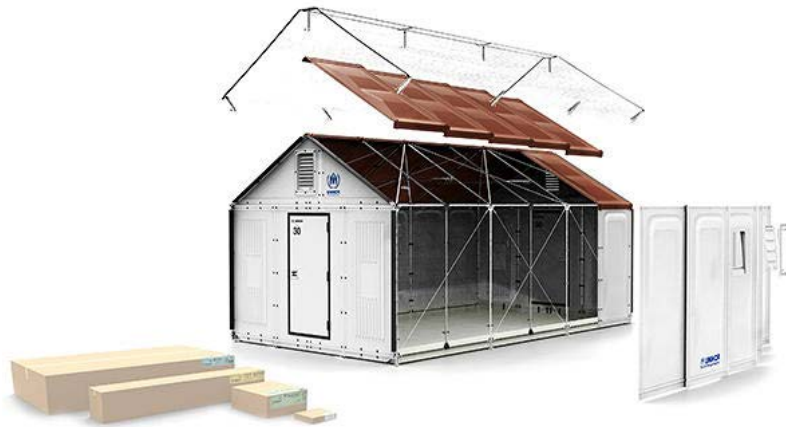
Figure 6.8. United Nations and IKEA Foundation Refugee Shelter

- these structures were designed for refugee camps, and their structural performance against natural hazards is unknown
- the original cost of \$10,000/unit would be too high, although if the structures were in mass production at \$1,000/unit the cost may be more reasonable for construction
- the shelter is not in character with existing structures in Nepal
- all materials come from outside of the country

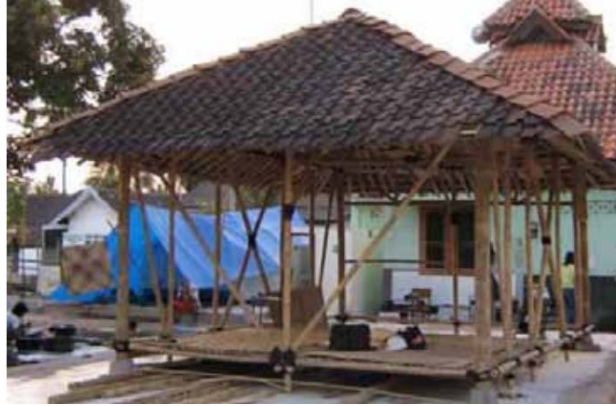
Figure 6.9. Semi-Permanent Bamboo Structures

A series of semi-permanent bamboo-framed structures were built after the September 2009 earthquake in West Java, Indonesia as shown in Figure 6.9²⁵. The dimensions of the structure were 6m x 4m in plan, and the structural system consisted of concrete foundations, terracotta roof tiles, bamboo columns and bracing, and bamboo matting walls.

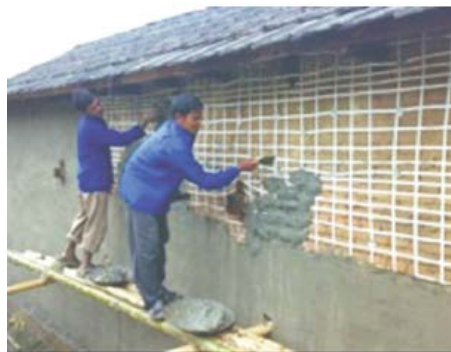
Figure 6.12. Retrofit of a house with polypropylene strips

One NSET technician, two masons, and two unskilled laborers conducted the work over four weeks, with a material cost of the retrofit at \$250. Construction is shown in Figure 6.12.

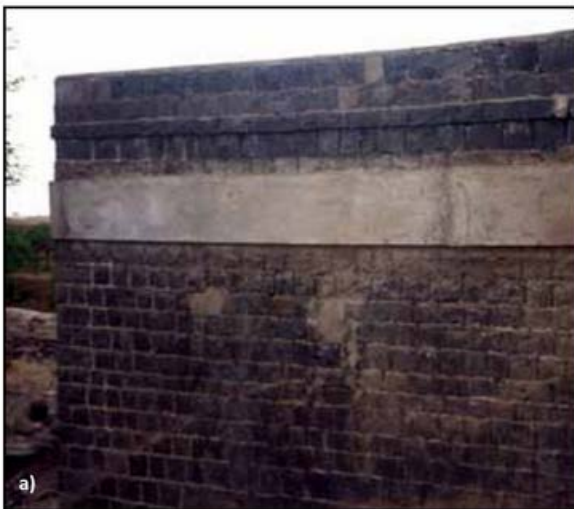
Figure 6.14. Reinforced concrete tie bands⁴

the wall with nails, layered with mortar, can be added as shown in Figure 6.14. Semi-skilled labor is required for this type of retrofit, however the skillsets required currently exist in Nepal.

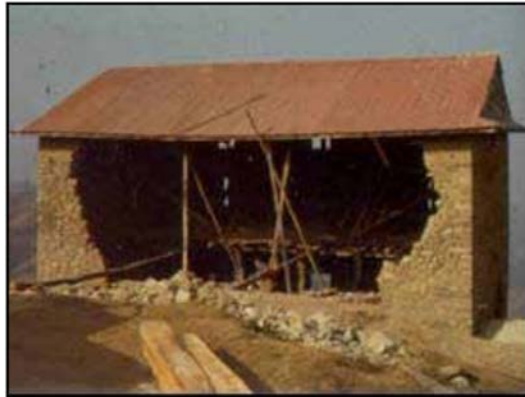
Figure 6.18. Out-of-plane failure of a stone masonry wall

Out-of-plane collapse is a common failure mode for masonry walls, and is depicted in Figure 6.18. As discussed a number of times previously, overall building integrity is critical for the seismic performance of masonry buildings, i.e. structural components must stay connected to each other. When cross-walls parallel to the direction of shaking are far apart, the central areas of long walls are subjected to significant out-of-plane vibrations, and are susceptible to collapse. This is exacerbated by inadequate connections between the walls at corners, between the walls and the diaphragms/roof, and the presence of flexible diaphragms/roof.

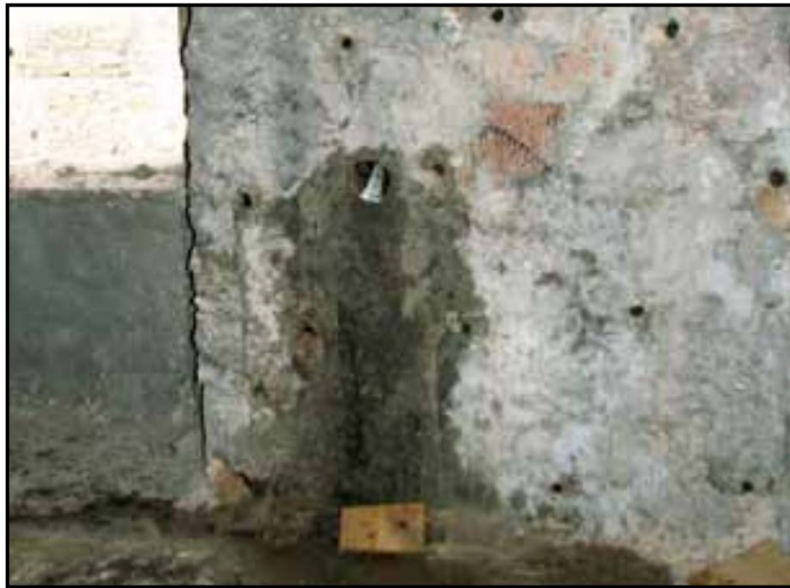
Figure 6.20. Masonry wall prepared for grout injection

Stone masonry walls can be strengthened by injecting cementitious grout into air voids. The hardened grout is effective in bonding the loose parts of the wall together into a solid structure. The injected grout is prepared by mixing Portland cement and pozzolana with water in the right proportion. The grout is injected into the wall at low pressure using tubes and nozzles, which are inserted into the joints between the stones, uniformly over the entire wall surface. A masonry wall prepared for grout injection is shown in Figure 6.20. More details about this technique can be obtained from ²⁸ and ²⁹.

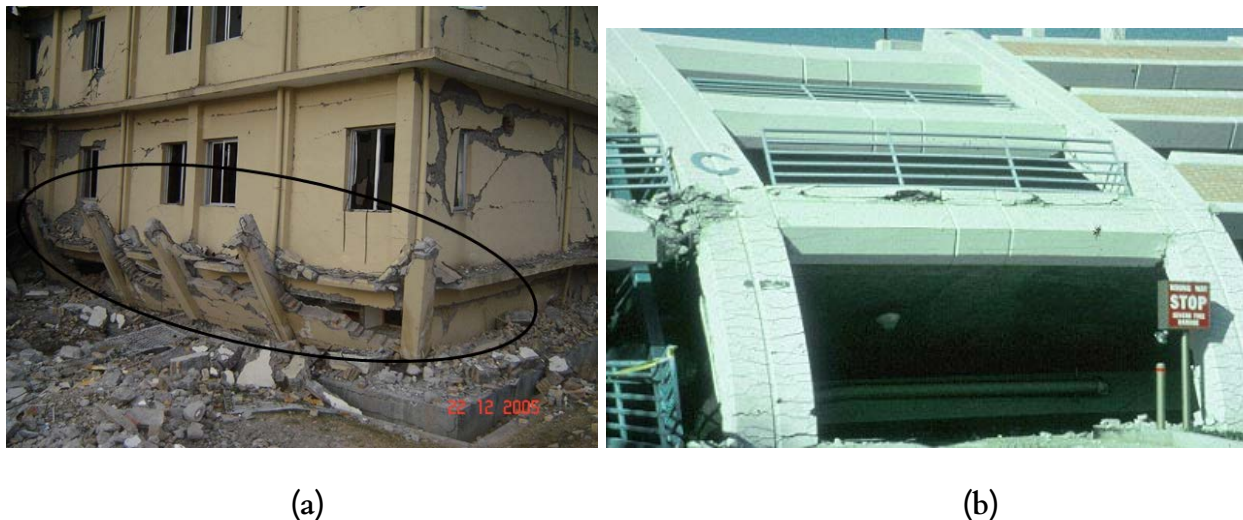
Figure 6.21. Failure of (a) non-ductile vs. (b) ductile RC framed buildings

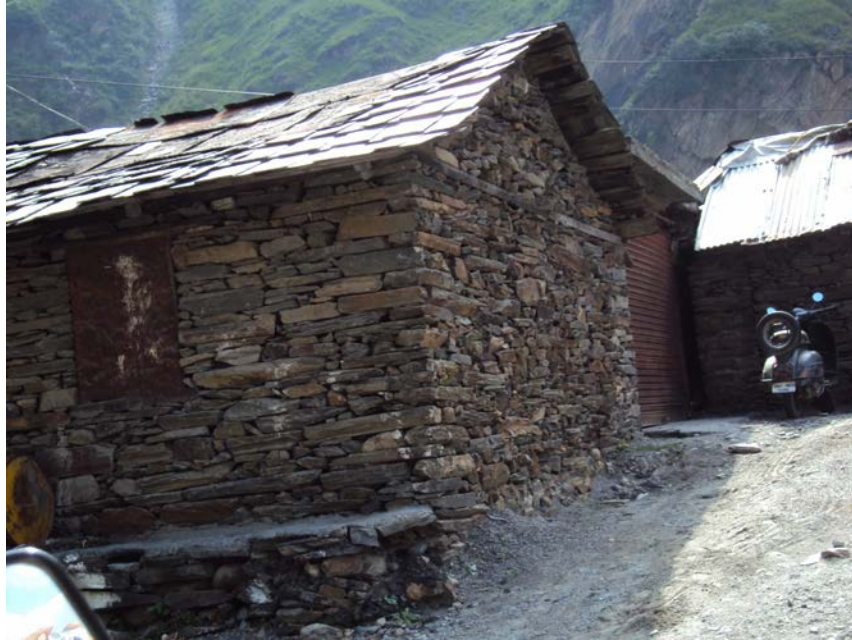
Figure 6.31. Example of uncoursed rubble stone masonry building

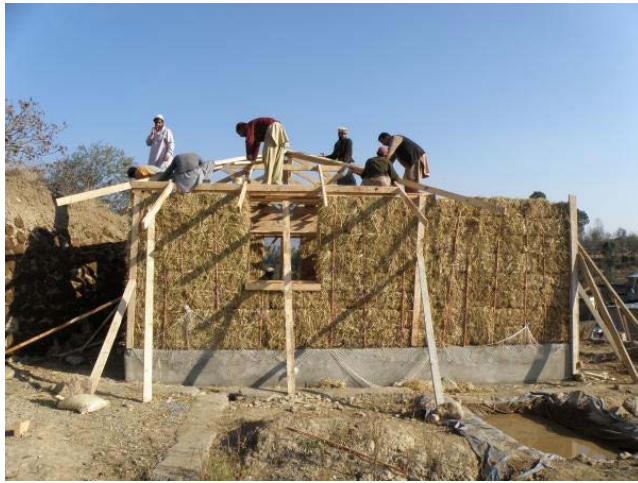
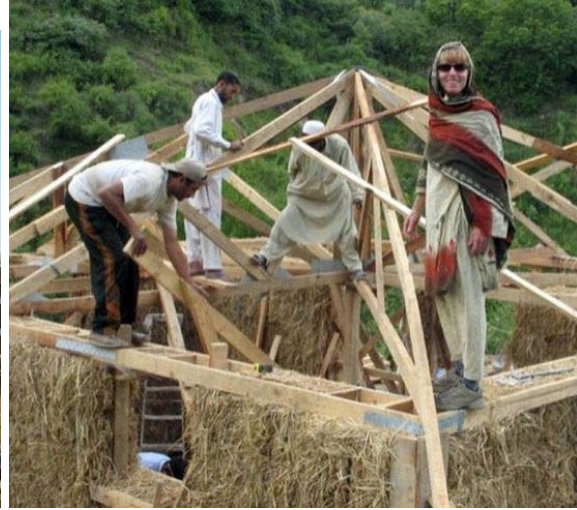
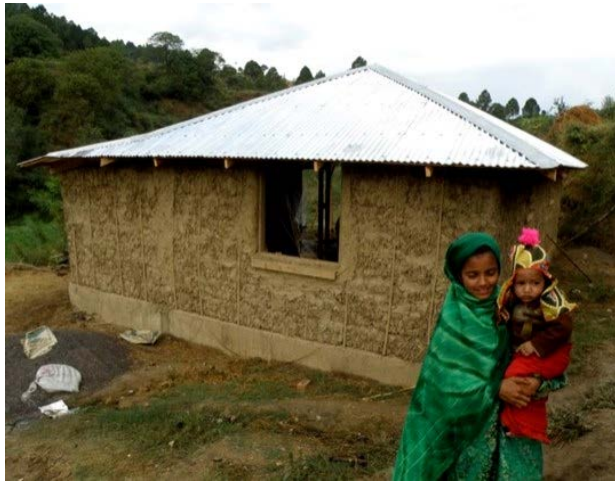
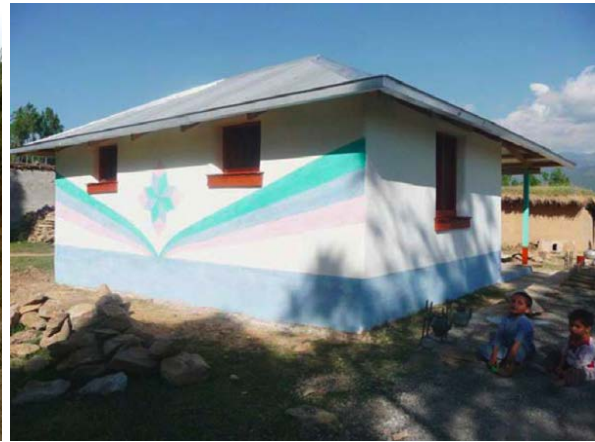
Figure 6.37. Straw bale construction

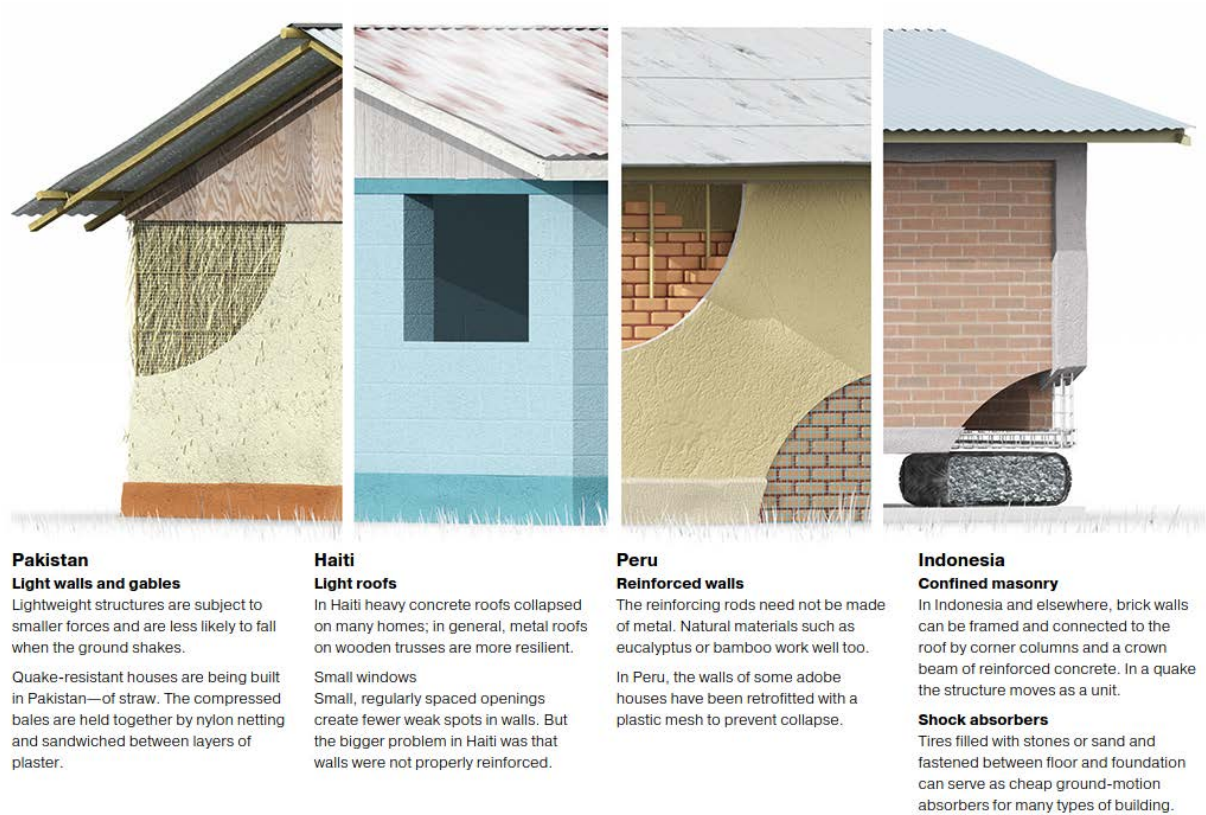
Figure 6.38. Alternative earthquake-resistant construction techniques proposed by researchers
